FREMANTLE PORT – BERTH 11

CONCRETE REPAIRS

1 Cliff Street
Fremantle, WA

LKS Constructions

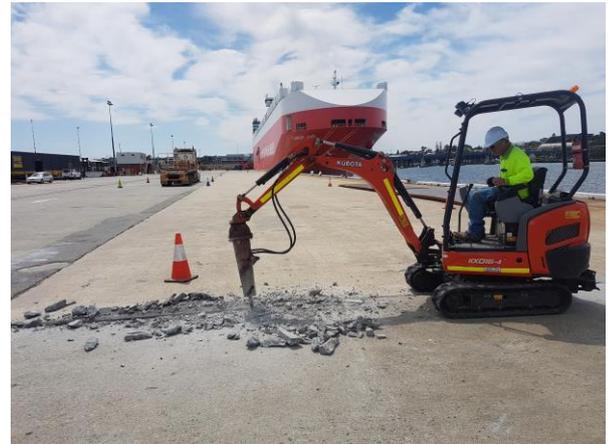
Fig.1 Excavator, with rock breaker, removing concrete

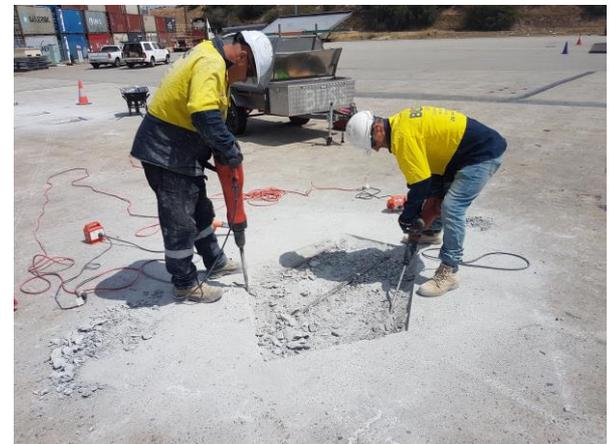
Berth 11 exhibited extensive areas of spalled and delaminated concrete resulting in the exposure of the steel reinforcement. BUSS' experienced concrete repair team completed the repair works as specified by Fremantle Ports engineering team; this included the provision of 50mpa concrete with Dramix steel fibres 65/35, bonded to repair surface with Parchem Nitobond EP, thus ensuring a robust and long-lasting repair.

Fig.2 Concrete breakout (under rebar) underway

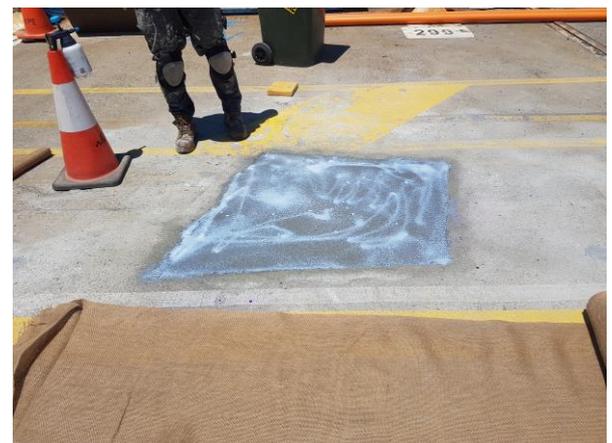
Fig.3 50mpa concrete repair, coated with Concure 99
