PERTH INTERNATIONAL AIRPORT

CONCRETE REPAIRS

Fire Training Facility
Perth International Airport, WA

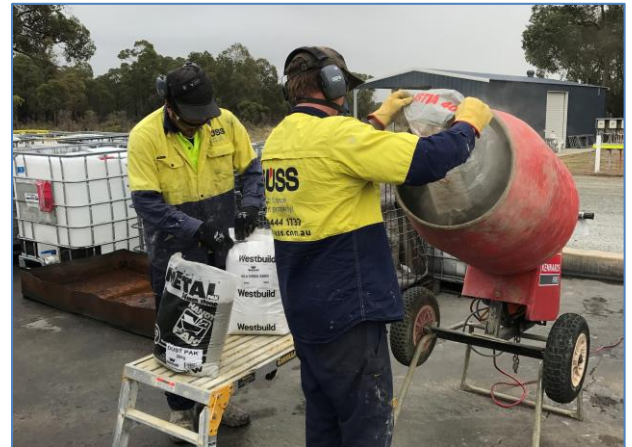
Fig.1 Preparation of bespoke heat resistant repair mortar

BUSS personnel removed the damaged concrete and primed the surface area in readiness for the repair mortar. The repair mortar, made on site with strict adherence to mixing ratios as per product instruction and engineering specification, was trowelled onto the primed surface; particular attention was paid to the reo bars and to ensuring flushness with the existing slab. The repair mortar used was a bespoke heat resistant product which was engineer designed to withstand extremely high temperatures necessary for the training facility.

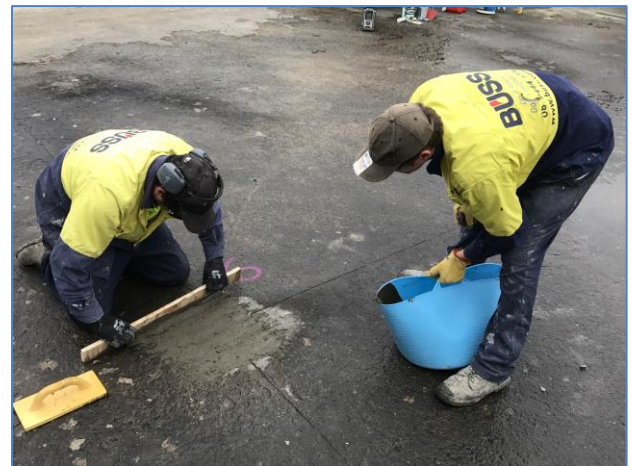
Fig.2 Repairs underway to one of multiple areas

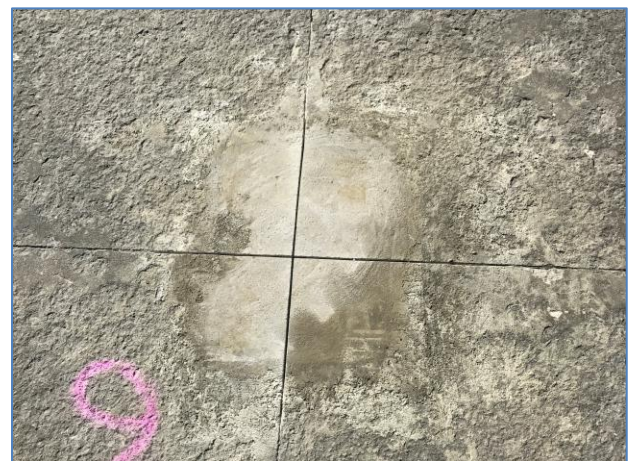
Fig.3 Finished repair

BUSS also reinstated saw cuts and undertook joint sealant works to the surface using a heat-resistant ceramic rope and fire rated joint sealant.
