SAINT GERMAIN APARTMENTS

ROPE ACCESS INSPECTION AND JOINT REPAIRS

8 Prowse Street
West Perth, WA

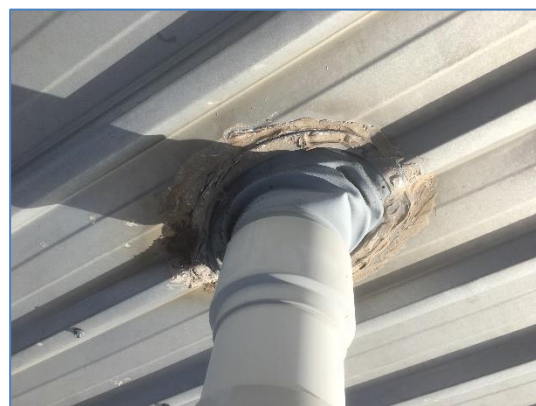
Image 2: Failed seal on roof penetration

BUSS mobilised to site and, via rope access, completed a thorough inspection of all penetrations to the exterior of the building's perimeter and the roof so as to identify failed joint sealing. The inspection results included the findings of failed seals at multiple penetrations to the roof and windows, as well as split roof sheet ridges. At the clients' request, BUSS completed all the repair works using our rope access technicians/applicators.

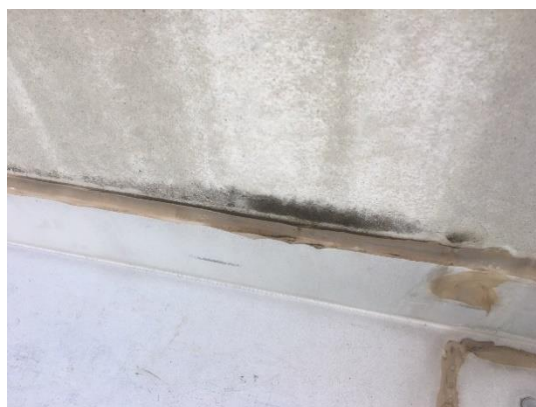
Image 3: Failed joint - window area
