# MONTREUX APARTMENTS

## BALCONY REPAIRS, TILING & WATERPROOFING

6 Parker Street  
Perth, WA

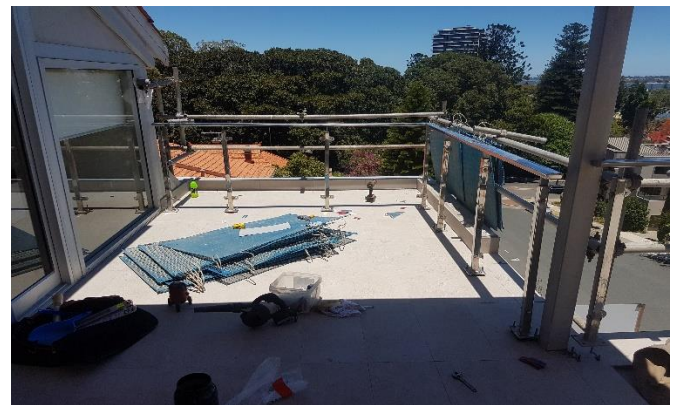
Fig.2 Tiling and balustrade installation in progress

Buss' work scope included the removal of the balustrades and installation of edge protection, removal of the tiling and screed via a waste chute and surface preparation of the concrete slab by grinding, prior to the installation of screed to fall. A new waterproofing membrane system was then installed, followed by reinstatement of tiling, drains and balustrades.

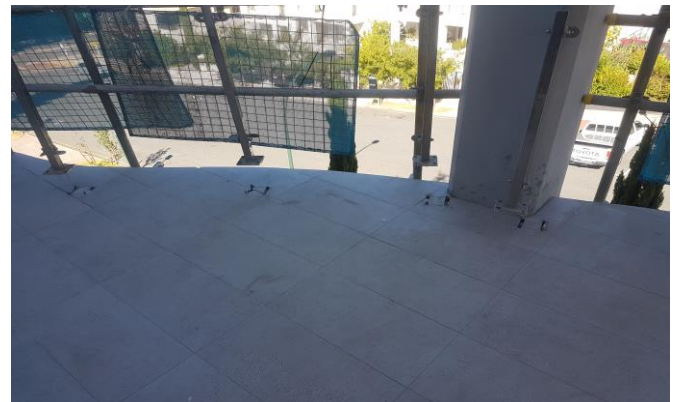
Fig.3 Completion of tiling and welding of balustrade bolts
