## BANKWEST SAFETY DEPOSIT VAULT - WATERPROOFING WORKS

300-306 Murray Street  
Perth, WA

BankWest

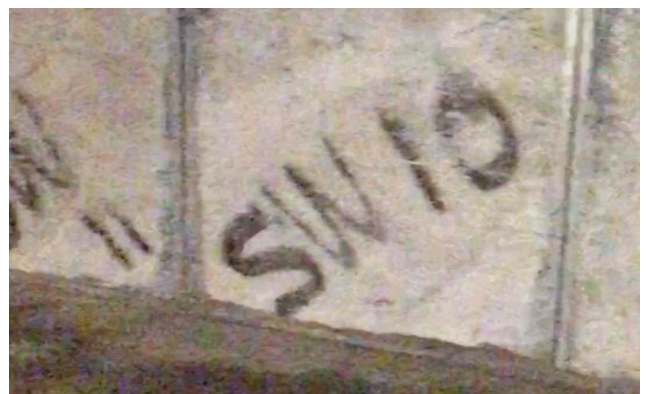
Image 2: Vault area pre-works

October 2017, the BUSS team installed the Sikadur Combiflex system to the vault area. The system has advanced adhesion, is very flexible whilst still maintaining a watertight seal; most suited to this environment.

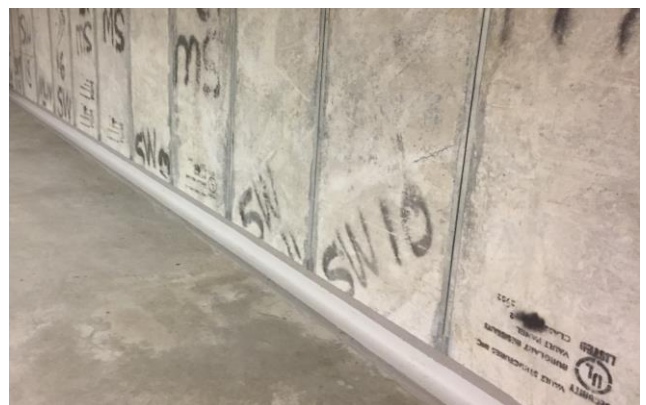
Image 3: Vault area upon works completion
