## HBF STADIUM CONCRETE REPAIR & REMEDIATION WORKS

100 Stephenson Ave  
Claremont, WA

VenuesWest

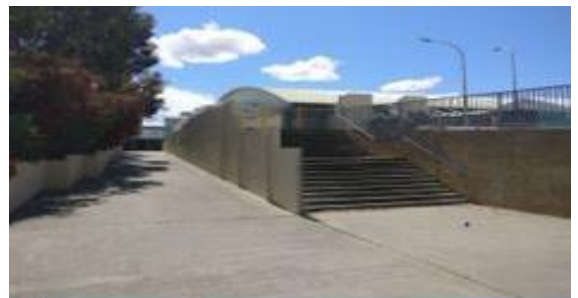
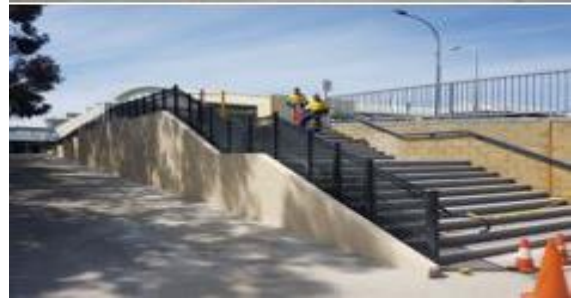
*Image 1: Stairway - before and after*

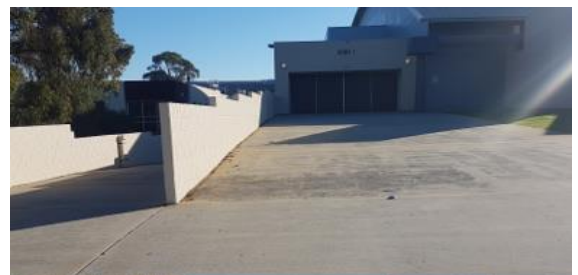
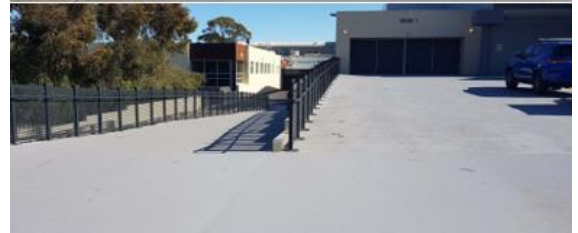
*Image 2: Door 1 entrance – before and after*
