92 BARRACK STREET HERITAGE BALUSTRADE REPAIRS

92 Barrack Street is located in the heart of Perth CBD, between Hay Street and Murray Street. It is a beautifully restored heritage building, housing commercial and retail premises.

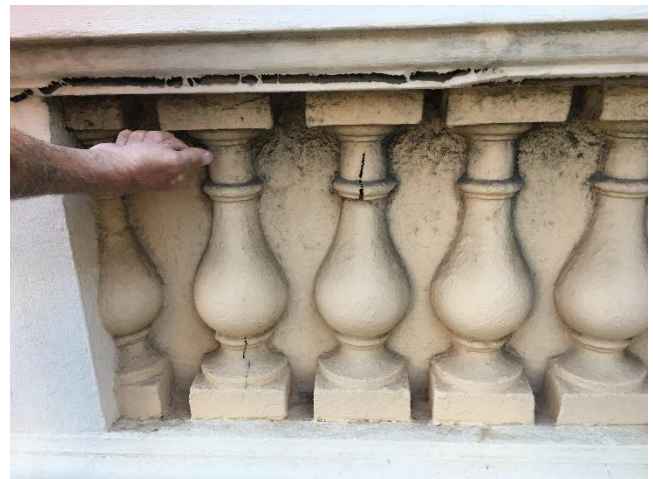
In March 2020, Lease Equity contracted BUSS Group to complete remedial repairs to the buildings concrete balustrade to the front façade of the roof top. The balustrade was exhibiting signs of deterioration, due to corrosion, in the form of cracks and spalling.

Image 2: Extensive concrete deterioration

BUSS utilised a specialised freestanding scaffolding system, erected through the studio windows and approved by a structural engineer, to access the balustrade/roof area. BUSS completed remedial repairs, which included concrete repair, cleaning of the steel reinforcement to remove corrosion, application of a corrosion inhibiting coating, reinstatement of the balustrade capping with repair mortar and coating with a UV/weather tolerant coating.

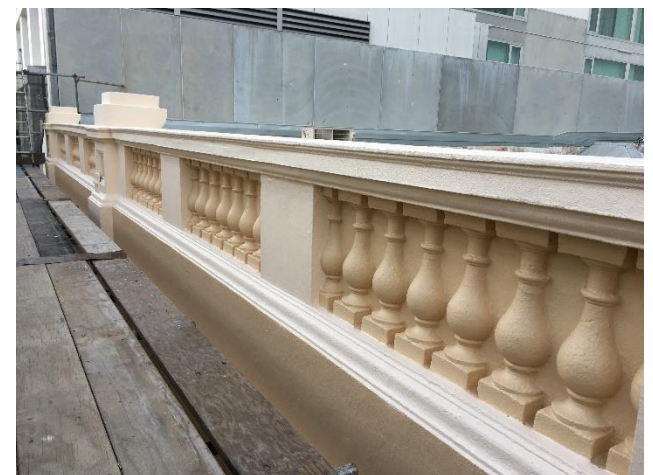
Image 3: Repairs completed; balustrade
