JOHNSON COURT ROOF TIE DOWN WORKS

23 Adelaide St
Fremantle, WA

DESCRIPTION

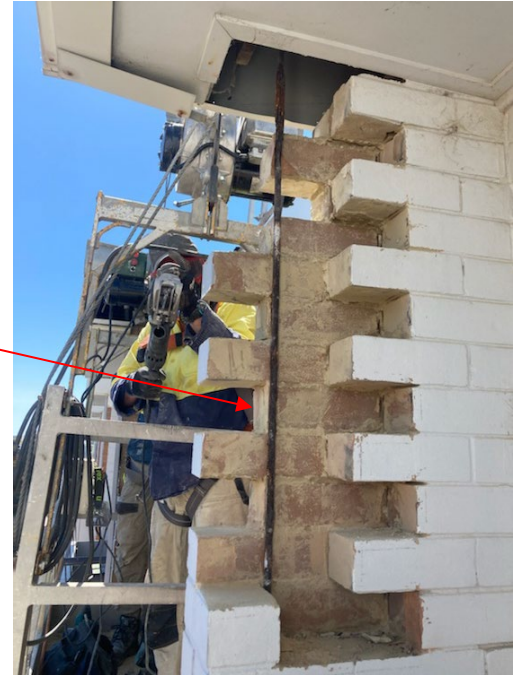
Corroded roof tie-down

Image 1: Demolition of cracked wall nib bricks exposing corroded roof tie-down

- Demolition of cracked wall nib bricks around the roof tie-downs;
- Installation of new hot dipped galvanised tie-downs;
- Reconstruction of the wall nib bricks around the new roof tie-downs with like for like bricks toothed into the existing;
- Brick and window sill repointing;
- Repainting of window lintels; and
- Installation of fixings to the roof structure (like for like).

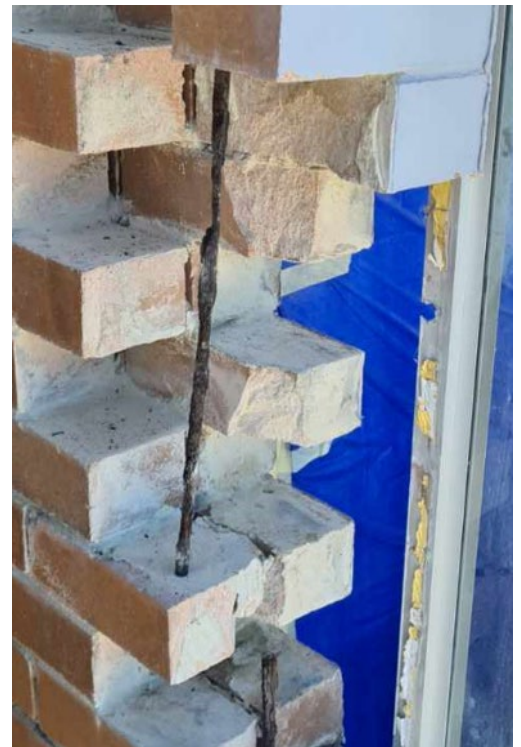
The report advised that the balcony wing walls of the 12 units on the upper floor were all cracked in a similar pattern; 23 nib walls in total. During the course of the assessment, a brick had been removed in one of the units to reveal a roof tie-down that was in an advanced state of corrosion. It was determined that the brick cracking, in each of the 23 balcony wing walls, was the result of the swelling of the corroded tie-downs.

Image 2: Corroded roof tie-down in wall nib

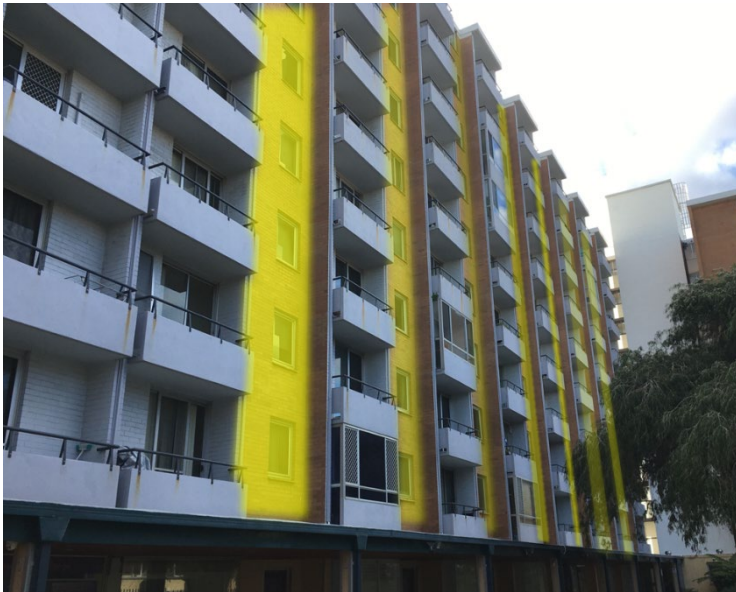
Image 3: Drops (shaded in yellow) to be repointed

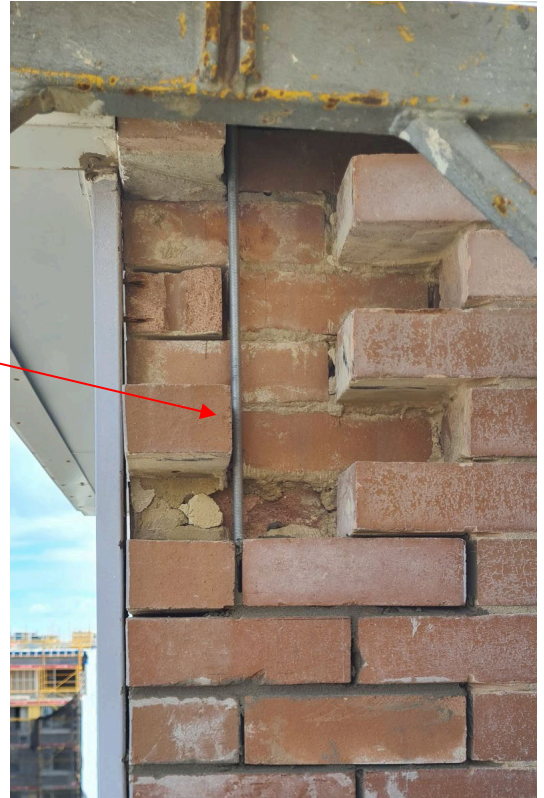
New hot dipped galvanised roof tie-down

Image 4: Reconstruction of wall nib bricks around new roof tie-down

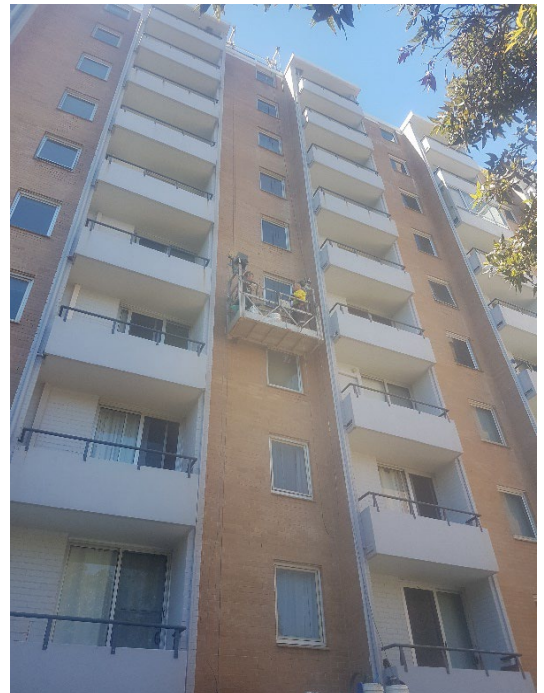
Image 5: Repointing works in progress
