RIVERVIEW APARTMENTS REMEDIATION WORKS

DESCRIPTION

Riverview Apartments, located in the heart of South Perth, is a brick and concrete structure comprising of 63 apartments over 9 levels.

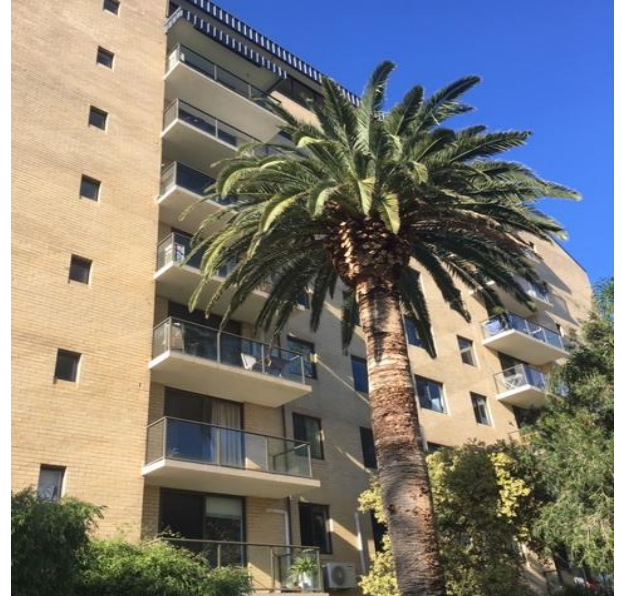
Image 1: Western façade of Riverview Apartments

- Removal of damaged and deteriorated mortar;
- Brick repointing;
- Application of water repelling sealant to the masonry wall of the west facing façade;
- Concrete repair to undercover carpark area and external carpark area; and
- Crack injection to undercover carpark soffit.

- To avoid accessing the work area via tenanted apartments, a specialised access system was erected externally to the structure;
- More than 750m² of bricks were remediated and sealed; and
- The works were successfully completed within budget and on schedule.

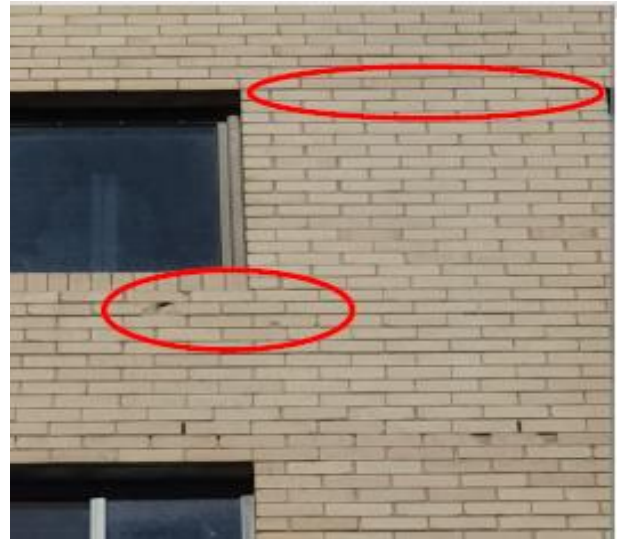
Image 2: Sample of façade areas requiring repointing

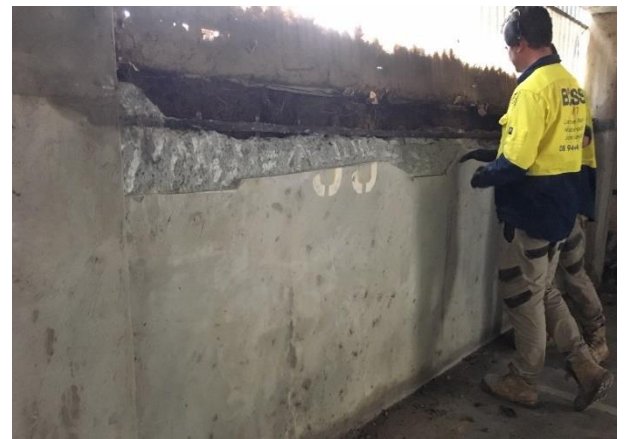
Image 3: Concrete repairs to undercover carpark
