310 Pier Street
Perth, WA

HBF Park, formerly known as Perth Oval and located close to Perth's CBD, is a sports stadium which hosts sporting events as well as concerts. The stadium has a maximum capacity of 21,000 people for sporting events and up to 34,000 people for concerts.

The external bricks and mortar were fretting, cracking and visibly loose on the western stand external brick wall. VenueWest put the repair works out to tender so that a suitable contractor could be appointed to complete the restoration works and prevent any further deterioration. In September 2021, BUSS was successful in award of the tender to complete the repair works.

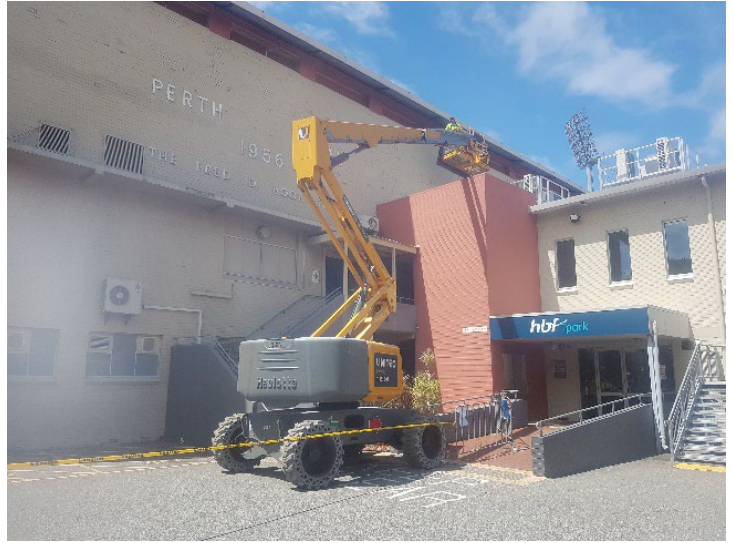
Image 1: Repairs to external brickwork in progress

- Installation of Helfix ties to the cracks that were evident in the brick walls;
- Re-point and re-paint the brick to match the existing, including the brick faces of the player tunnels leading from the field of play and the brick faces of the ambulance race down to the field;
- Repair to concrete toppings; and
- Reinstatement of the corroded/delaminated cast in steel stubs, removal of the brickwork as required and rebuild.

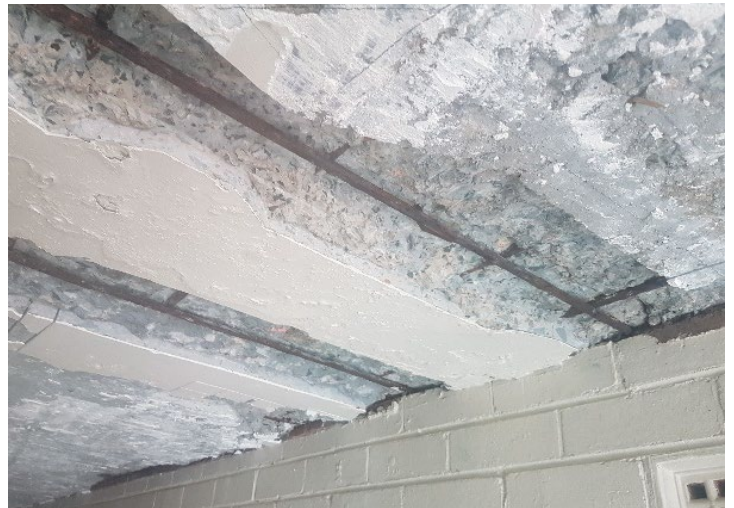
Image 2: Concrete breakout to tunnel ceiling
