CURTIN UNIVERSITY - BUILDING 204

DECK REMEDIATION AND WATERPROOFING

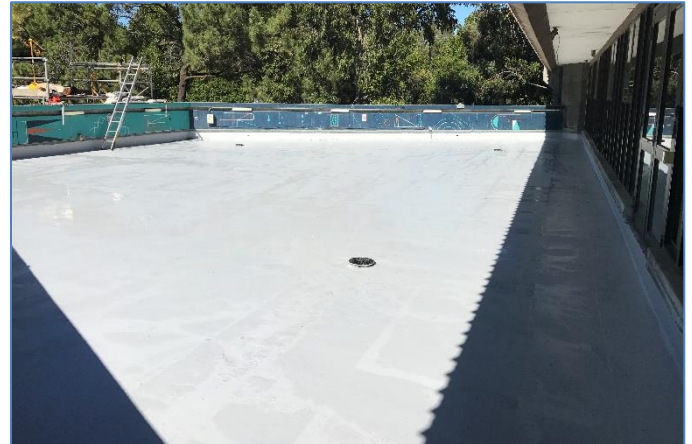
Fig.1 Completion of the five-layer waterproofing system

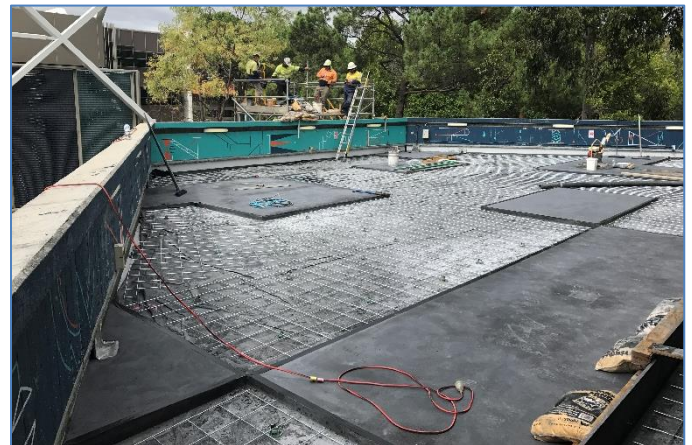
Fig.2 Concrete slabs - pour one, of two pours, completed

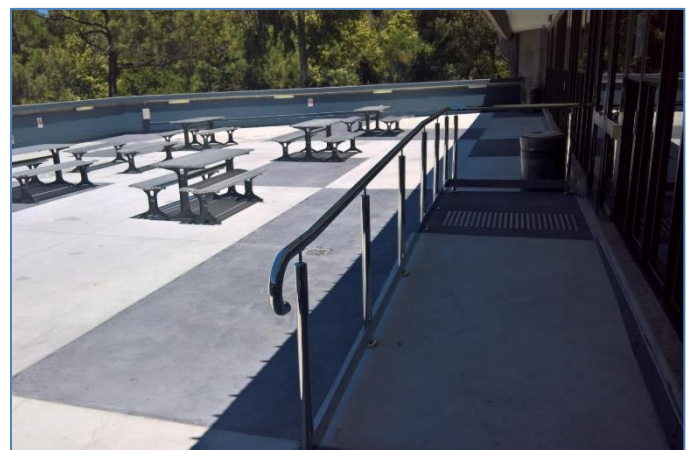
Fig.3 Newly completed deck refurbishment
