MOUNT CLAREMONT PRIMARY SCHOOL

CONCRETE REPAIR

103 Alfred Road
Mount Claremont, WA.

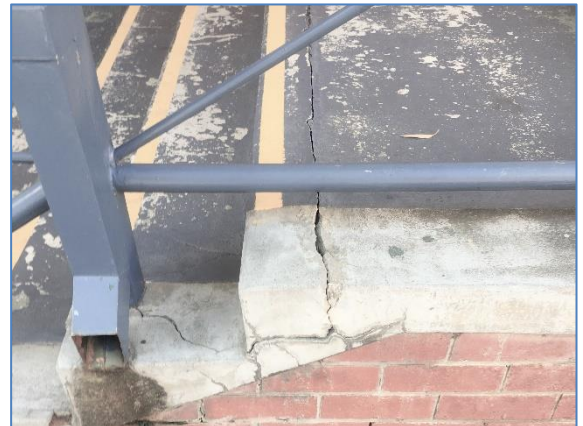
Fig.1 Damaged concrete presenting safety hazards

The work scope was executed by BUSS concrete repair specialists who saw cut the perimeter of each of the concrete defects, ensuring a neat finish, and then proceeded to break out and remove the damaged concrete. The exposed reinforcing steel was cleaned and an anti-corrosion coating applied, prior to the installation of a high-quality concrete repair mortar using a form and pour technique. The repair areas were then smoothed to ensure the finish matched the existing and a non-slip coating was applied throughout.

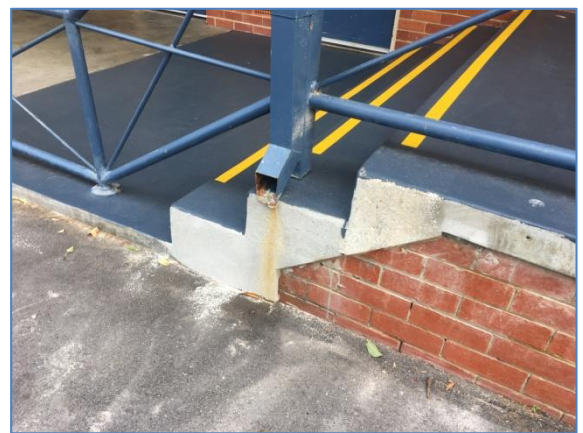
Fig.2 Repairs completed – safety hazards eliminated

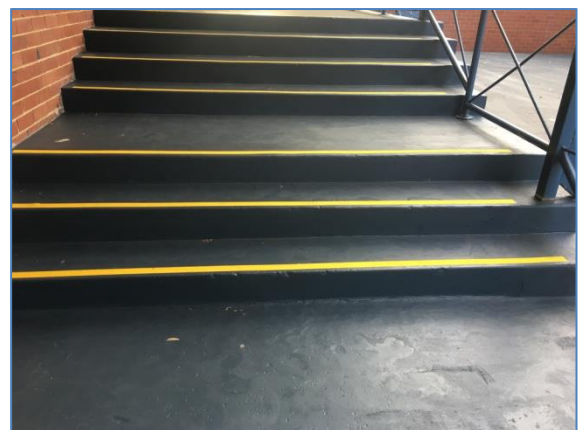
Fig.3 Hazard free stairs with uniform appearance
