## COLLIER PARK WATER TANK CONCRETE REPAIRS

Swan View, WA

Shire of Mundaring

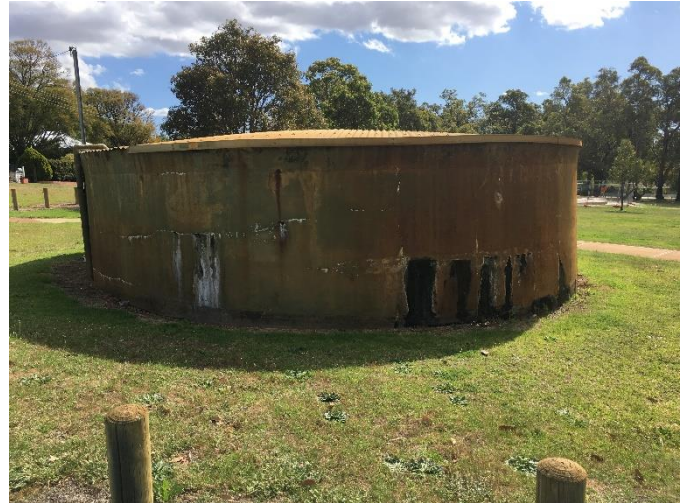
*Image 1: Water tank at Collier Park*

The Shire arranged for the tank to be drained and BUSS' team mobilised to site to complete the repairs once the tank had been emptied. The repairs were completed using a specialised system of repair mortars and products that comprised of impregnating crystalline technology which works to impede the passage of water and therefore prolong the serviceable life of the structure.

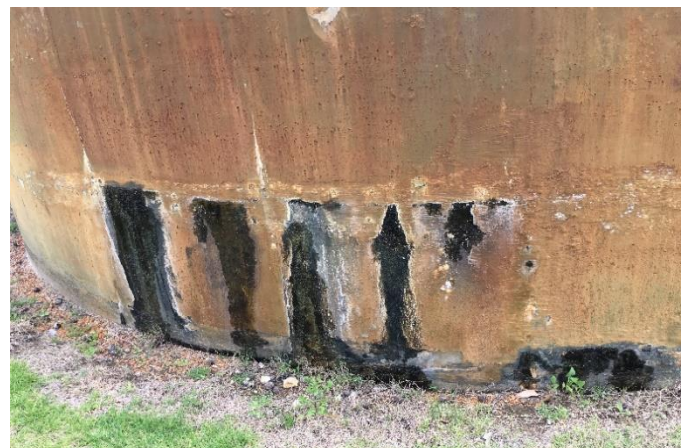
In late 2019, BUSS completed concrete repair works to three concrete water tanks in the Shire of Mundaring – Sawyers Valley, Salisbury Park and Darlington Oval. In January 2020, following on from the successful completion of the previous works, the Shire retained BUSS' services once again to complete concrete repair works to the water tank located at Collier Park in Swan View. This water tank was leaking due to multiple cracks and spalling of the concrete.

*Image 2: Concrete spalling at base of tank*

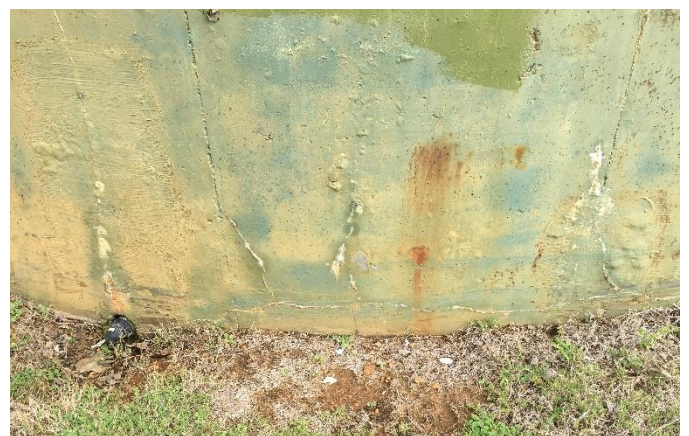
*Image 3: Defective concrete*
