## DARLINGTON OVAL WATER TANK CONCRETE REPAIRS

Pine Terrace, Darlington

Shire of Mundaring

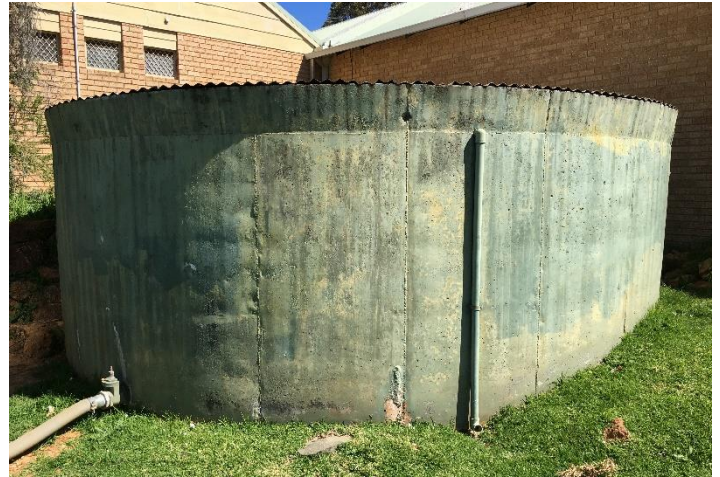
Having completed concrete repairs to the water tanks at Sawyers Valley and Salisbury Park, the Shire of Mundaring secured BUSS' services again to complete concrete repairs to the water tank at Darlington Oval in Darlington. The tank, which stored water for the oval's reticulation system, was leaking and upon our inspection showed various signs of damage to the concrete.

*Image 1: Water tank exhibiting various signs of damage*

In December 2019, once the tank had been emptied, the BUSS team mobilised to site. The concrete repairs were completed using specialist repair products, with impregnating crystalline technology, that will prolong the serviceable life of the structure by impeding the passage of water.

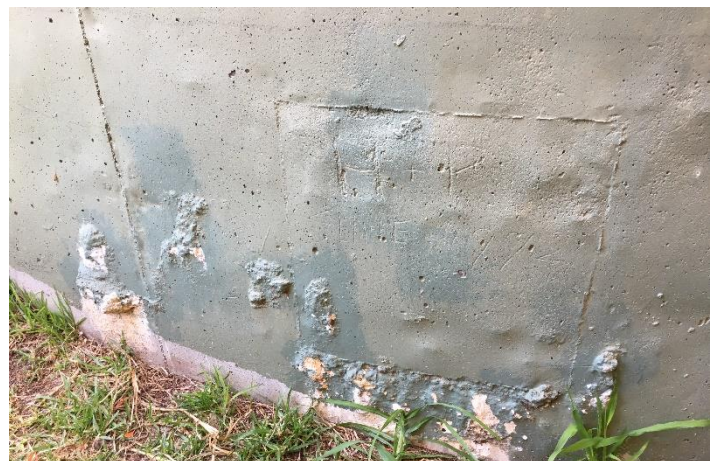
*Image 2: One area of damaged concrete*

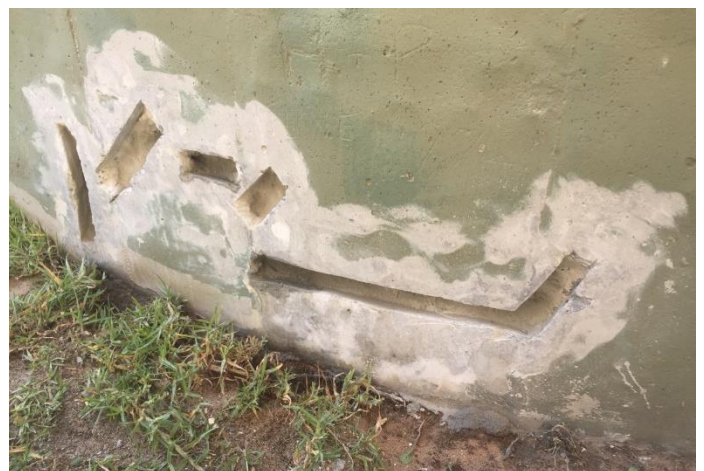
*Image 3: Preparation works for a repair area*
